This errata sheet provides updated information about known device issues affecting Arria® II GZ devices.

## Introduction

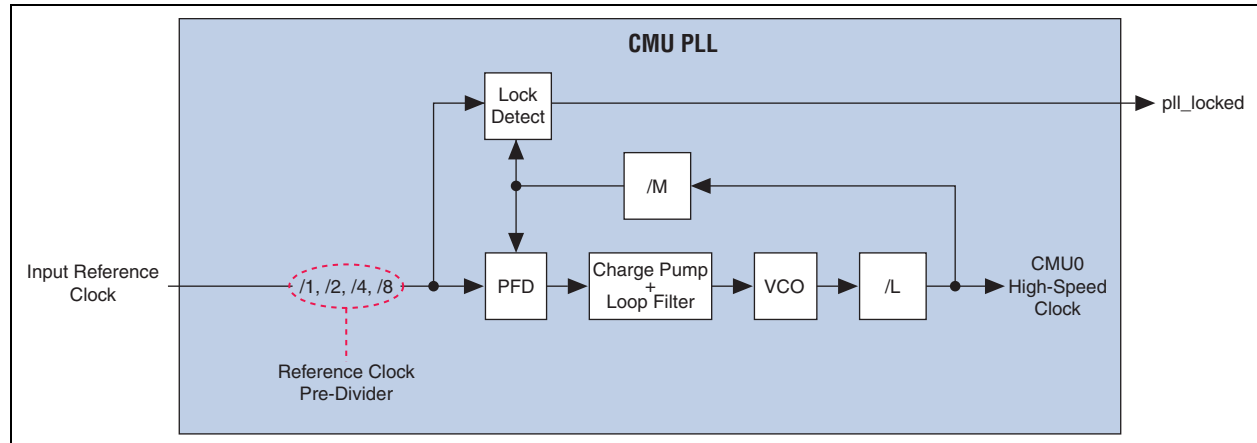
**Figure 1. Reference Clock Pre-Dividers in Transmitter PLLs**

The transmitter phase-locked loop (PLL) lock status signal (pll\_locked) does not de-assert when the pll\_powerdown signal is asserted in configurations that use the reference clock pre-divider of 2, 4, or 8. Figure 1 shows the reference clock pre-divider inside transmitter PLLs. This issue impacts the pll\_locked status signal in the clock multiplier unit (CMU) PLL.

- Designs that implement the recommended transceiver reset sequence described in the *Reset Control and Power Down in Arria II Devices* chapter in volume 2 of the *Arria II Device Handbook* could potentially see a link failure after coming out of reset.

If the `pll_locked` issue impacts your design, instantiate and connect the `pll_locked_soft_logic` module, as shown in [Figure 3](#). You must use the `pll_locked_to_corelogic` output from this module in the transceiver reset logic and any user logic that relies on the transmitter PLL lock status signal.
